CASE STUDY

Modern Steel Mills LLC (Oman)

Concrete Repair : Cooling Tower Tanks

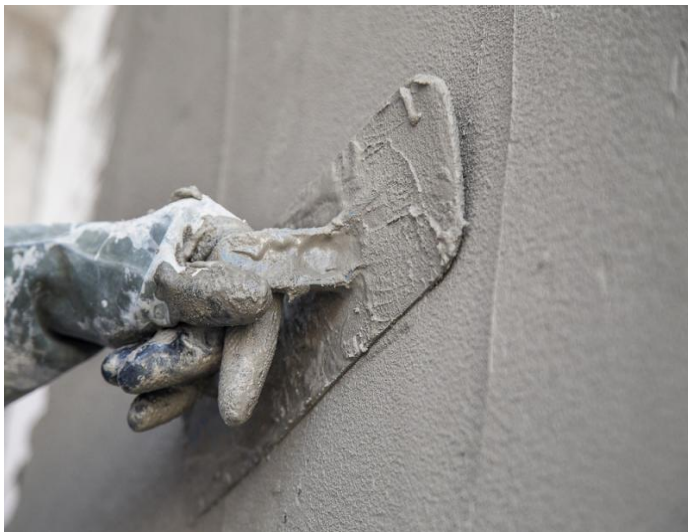
A range of advanced solutions, far beyond the simple concrete patch, was utilized to implement an effective concrete repair program. The first phase of the repair program was the cooling tower tanks. The extend of corrosion in the tanks were high, spalling had caused exposure of the reinforcement in many areas. The extend of corrosion on the tank roof slab was beyond repair and decision to demolish it and re-construct it was taken.

- All loose concrete was removed.
- Corroded reinforcement was exposed.
- Areas where the steel was badly corroded new reinforcement were installed with chemical anchoring – Fosroc Lokfix DUR.
- All the exposed steel was treated with a zinc rich primer – Fosroc – Nitoprime Zincrich.
- Concrete repairs were carried out with Fosroc - Rendroc LAXtra and Rendroc HSXtra repair mortars.
- Resin injection in tanks were required – Fosroc Nitofil EPLV
- Epoxy bonding agent was used to enhance the bond between the old and new concrete Fosroc – Nitobond EP.
- The cooling tower water tank was protected with Fosroc – Nitocote EPS and the drinking water tank with Fosroc – Nitocote E405.

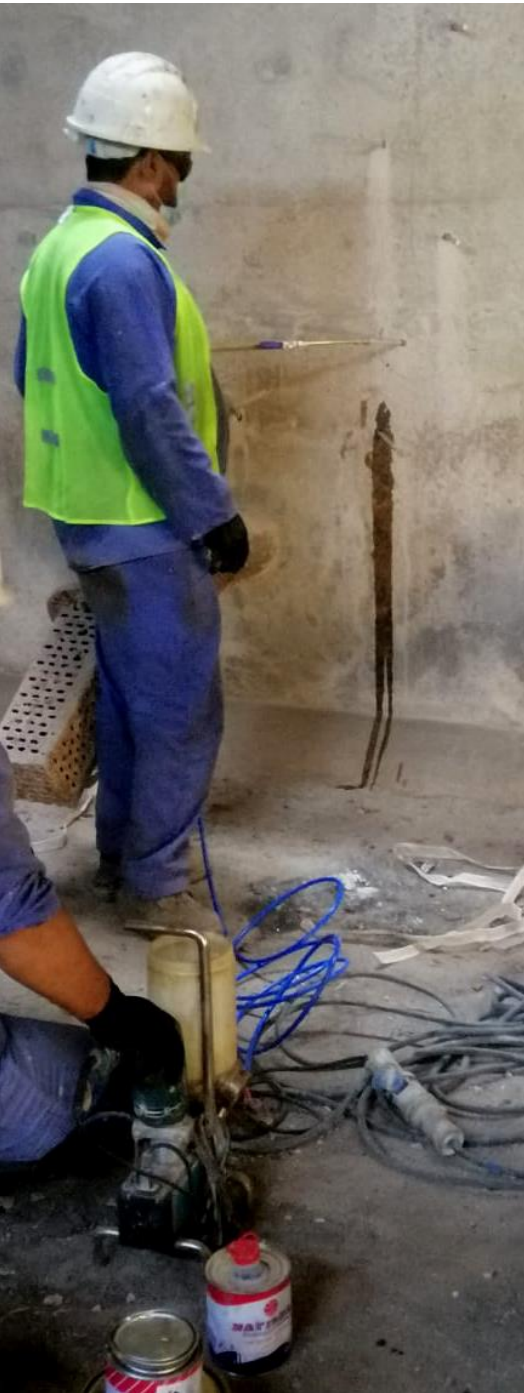
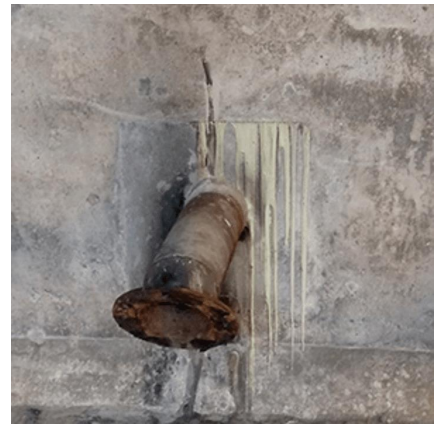
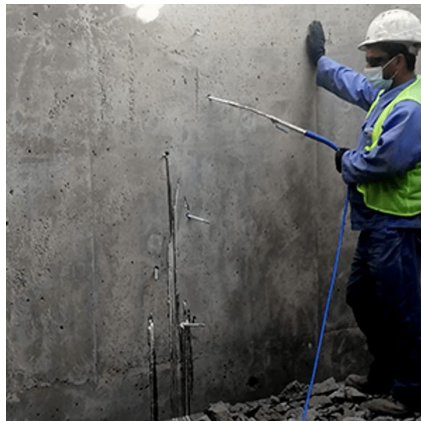
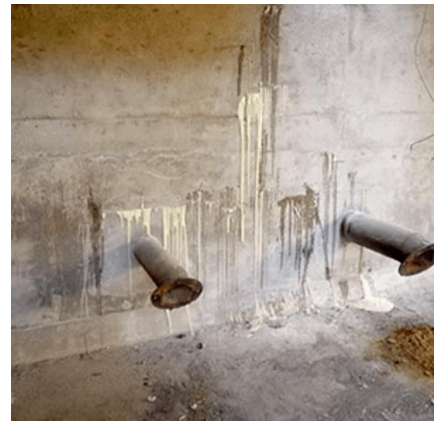
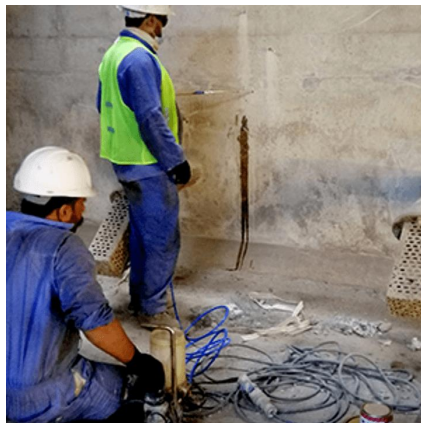
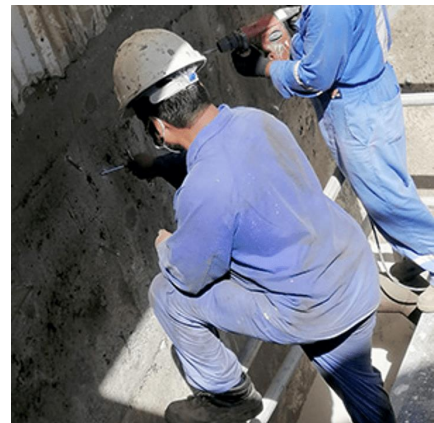
Photos of Resin Injection in tanks

Carbonation, movement or poor construction can cause dangerous cracks in concrete structures, leading to the appearance of leaks and water penetration. Resin injection is designed to inject and seal the cracks that appear in reinforced concrete.
